Modifying a Hammond Glider

By Bob Vaughan

The objective with this Hammond glider modification was to modify it to accept the 8-1/2 inch size blade so popular on miter saws plus install a single phase motor and get the saw up to 4500 rpm by installing new pulleys.

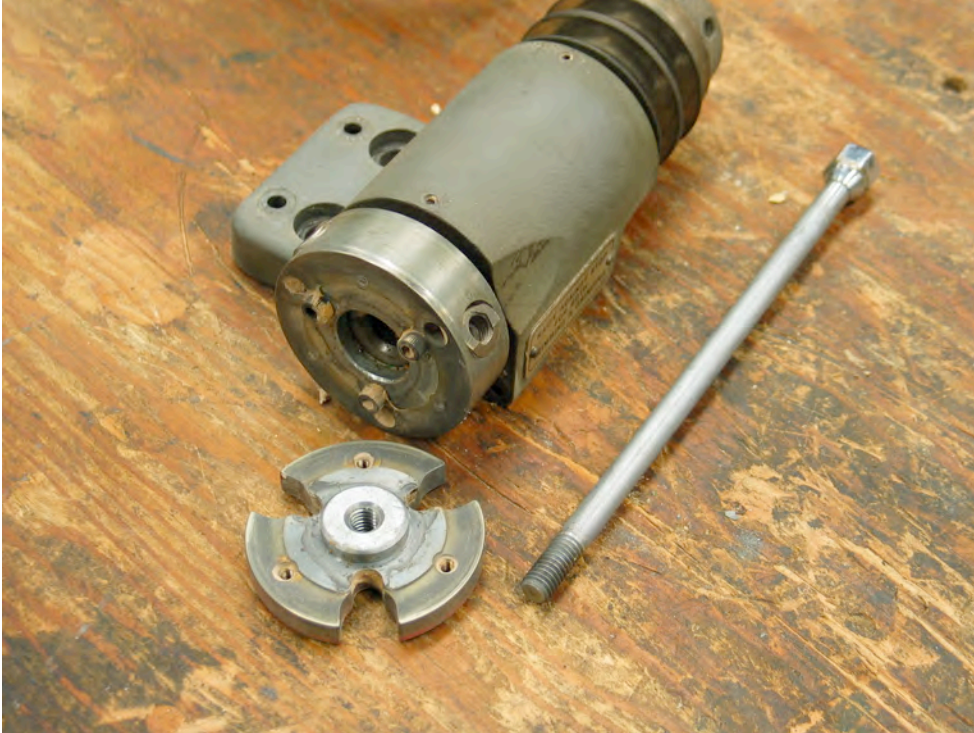
Figure 6 Drawbolt has been removed along with the face piece.

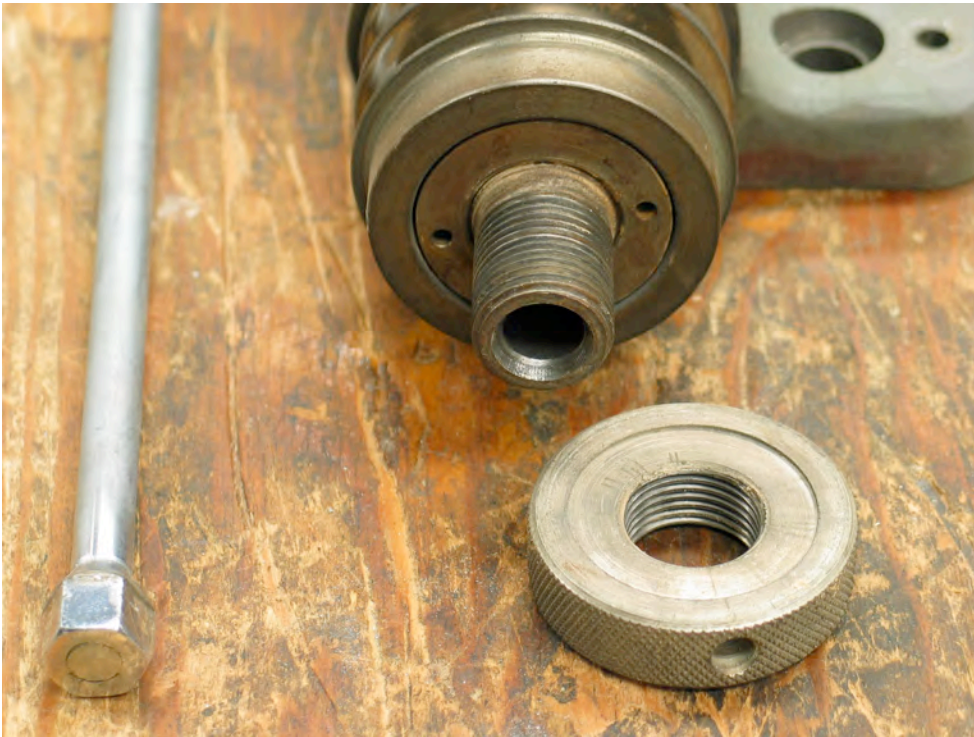
Figure 7 Auxiliary threaded ring removed to expose spanner nut that holds the pulley against the bearing. The auxiliary threaded ring will be discarded.

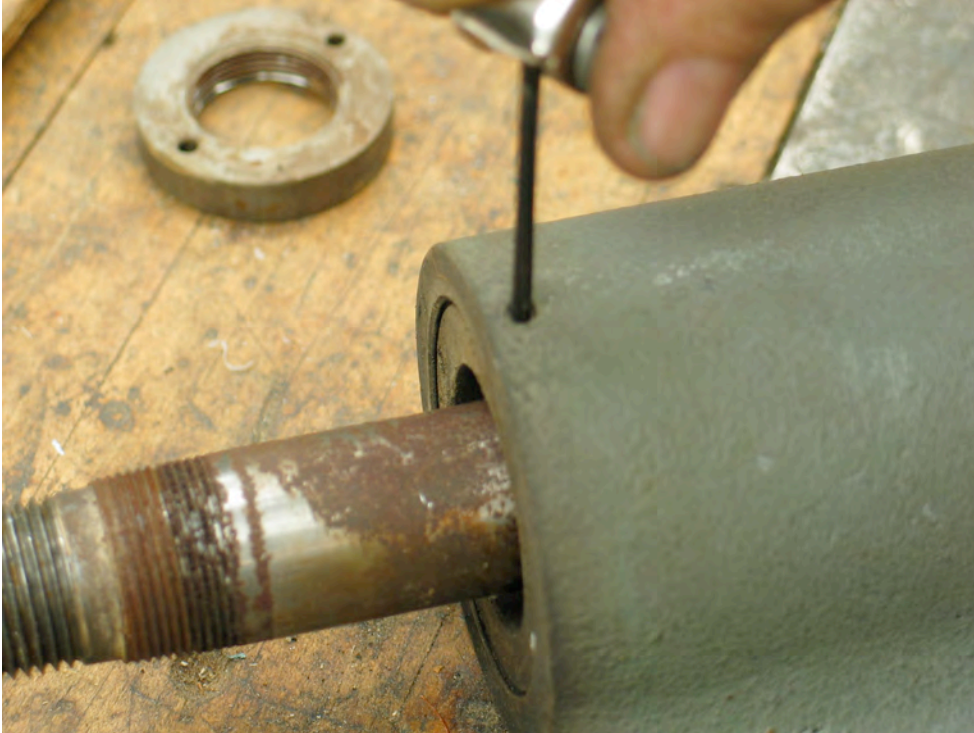
Figure 8 remove the two setscrews that hold the bearing retaining rings. Be careful to keep the brass compression stud under the setscrews.

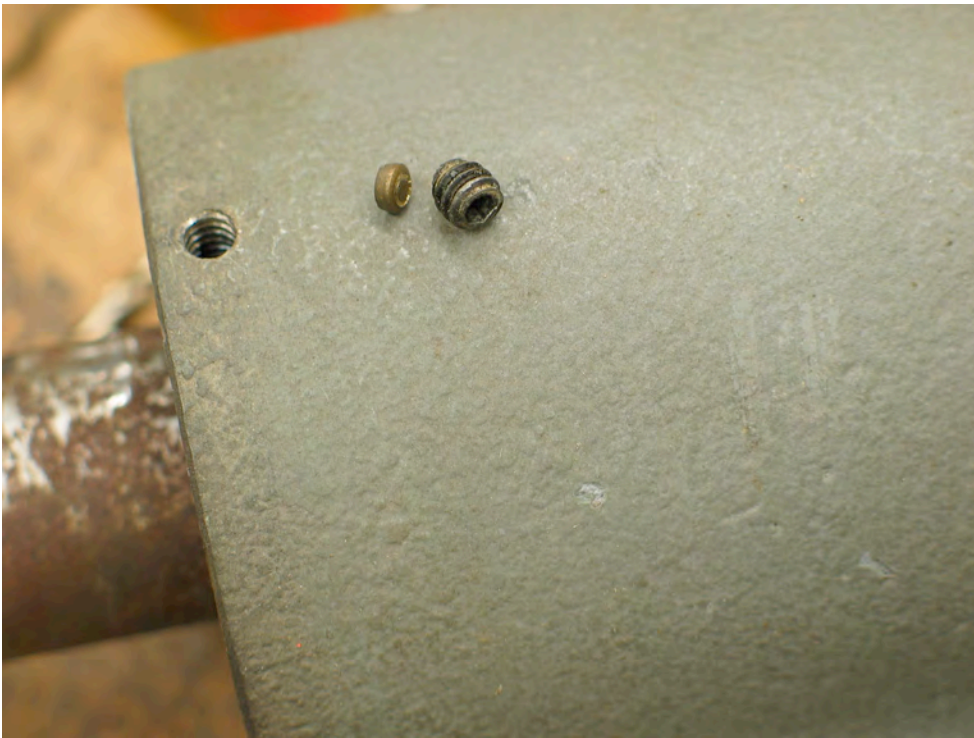
Figure 9 Detail of setscrew and compression stud

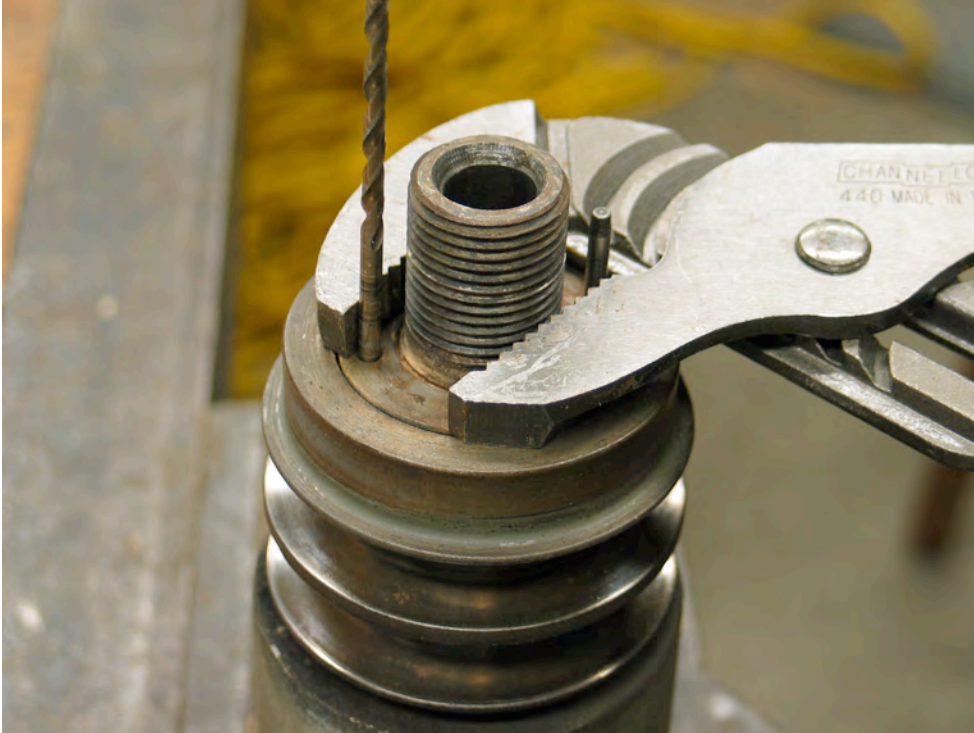
Figure 10 To break the friction, install a couple of 1/8 inch pins as studs and twist if you don't have the right size spanner wrench.

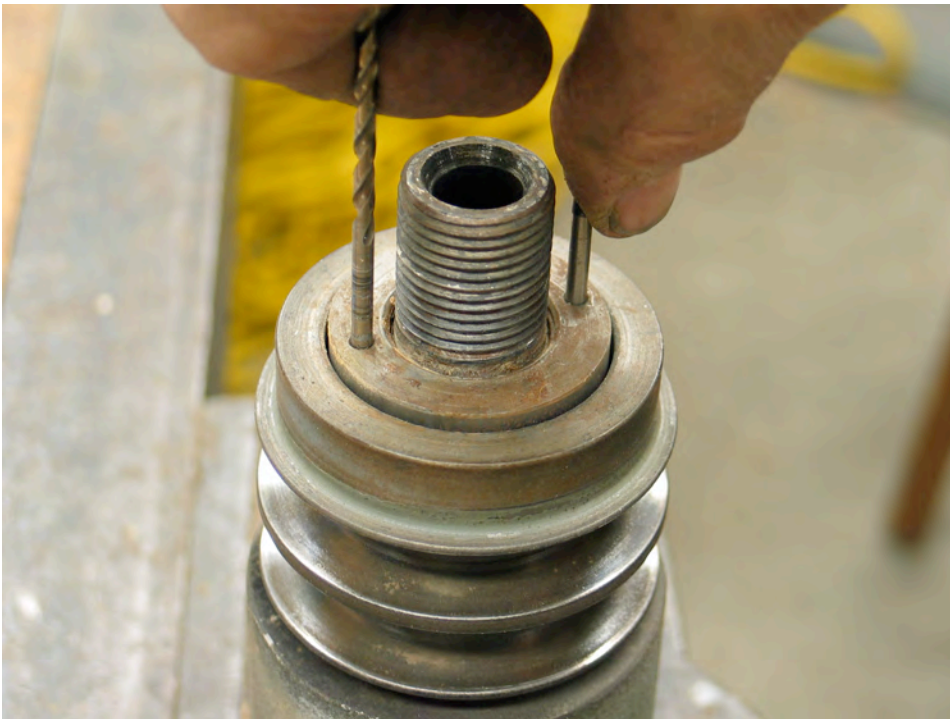
Figure 11 Once the spanner nut is loose, remove with hands.

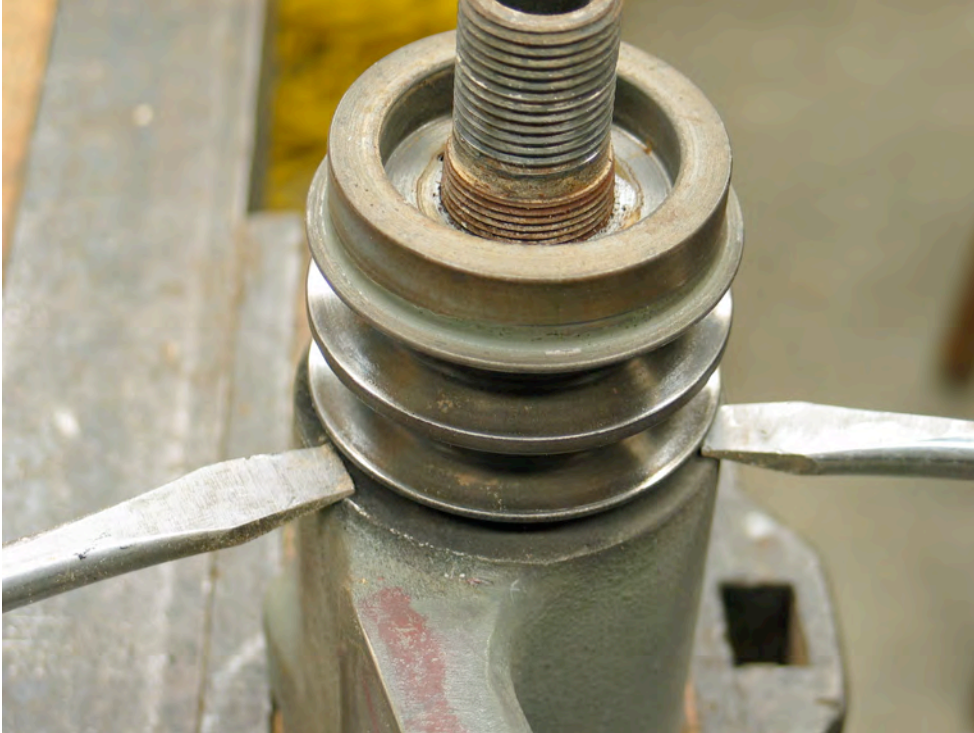
Figure 12 Pry off pulley with a couple of screwdrivers. Remember, there is a woodruff key under the pulley.

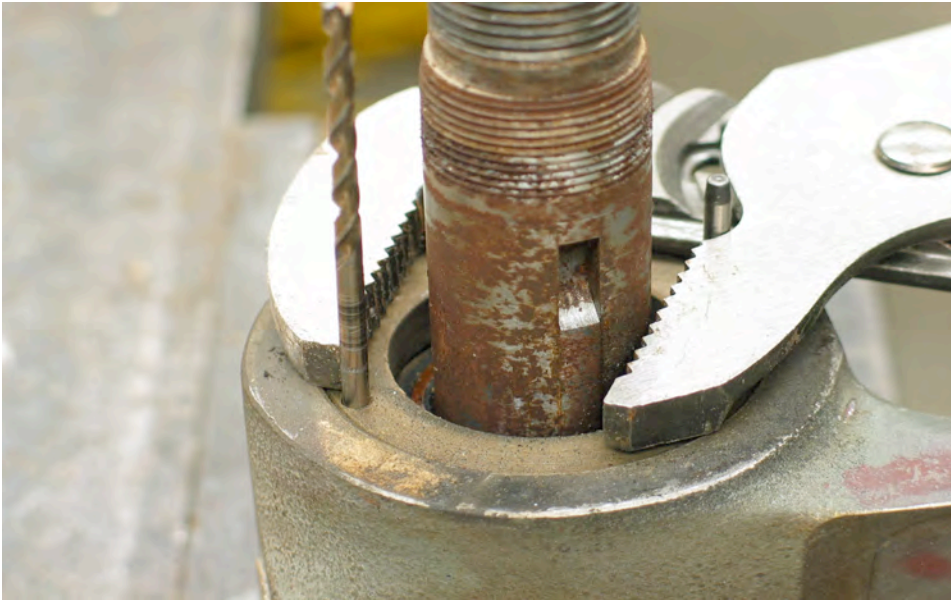
Figure 14 Only light pressure should be required to get the outer race spanner nuts turning as they put very little force against the bearings.

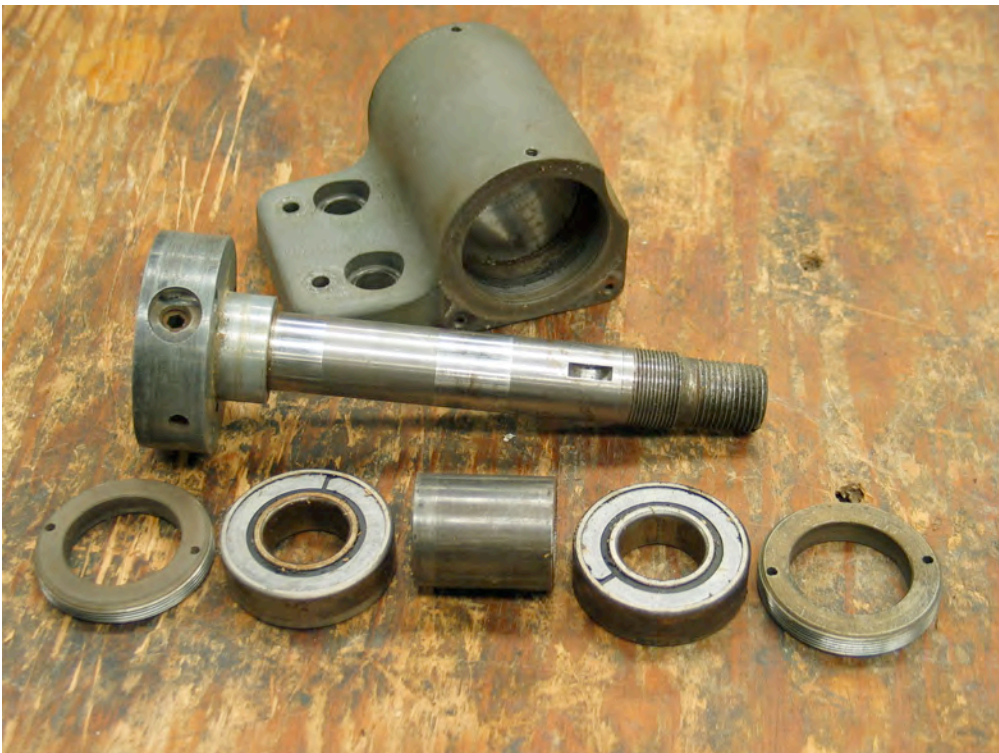
Figure 15 The entire assembly is shown here. When re-assembling, the two brass spanner nuts will screw in and out to adjust the position of the blade flange. There should be light hand pressure compression on these two nuts. That's all the preload needed.

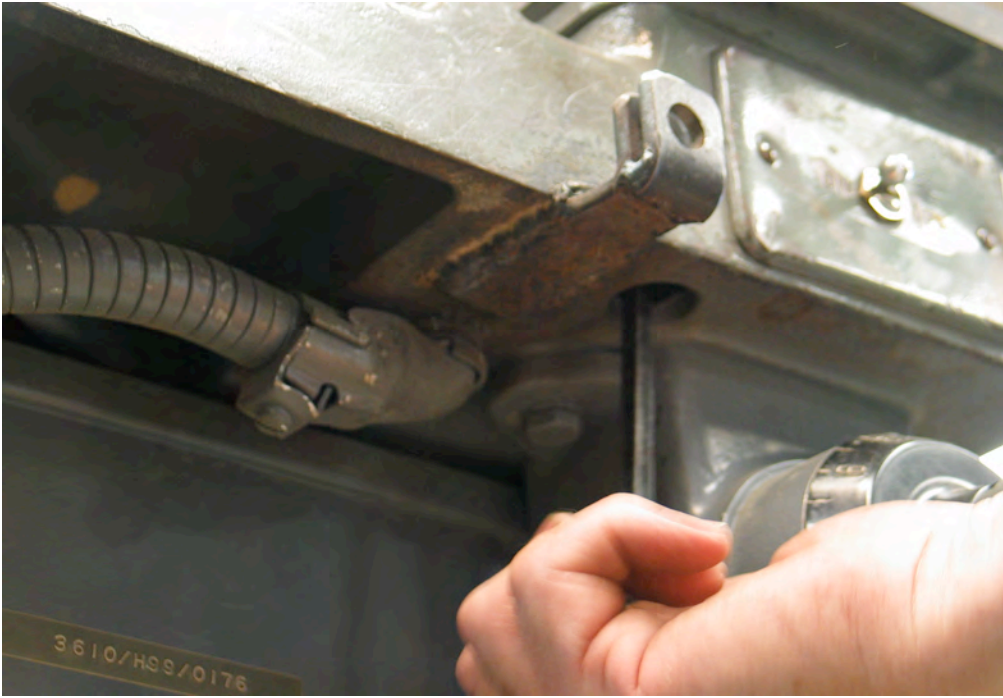
Figure 16 Now that the top is out, the table needs to be removed by removing three socket-head cap screws

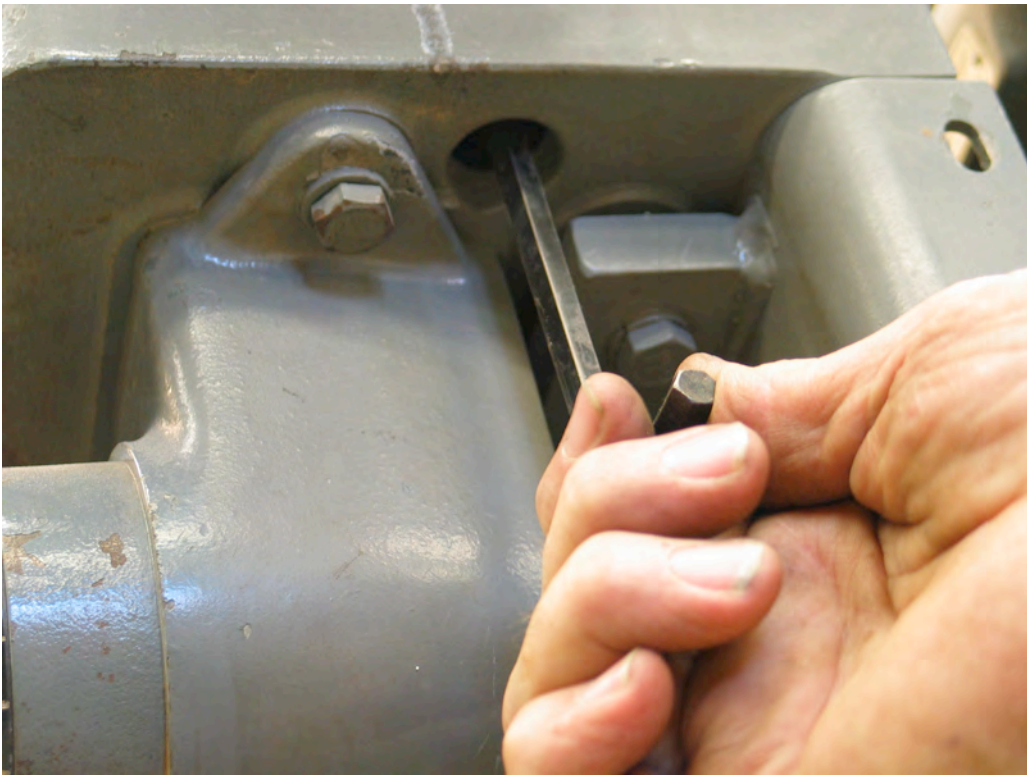
Figure 17 Like the first cap screw, access to the second is through a hole in the casting

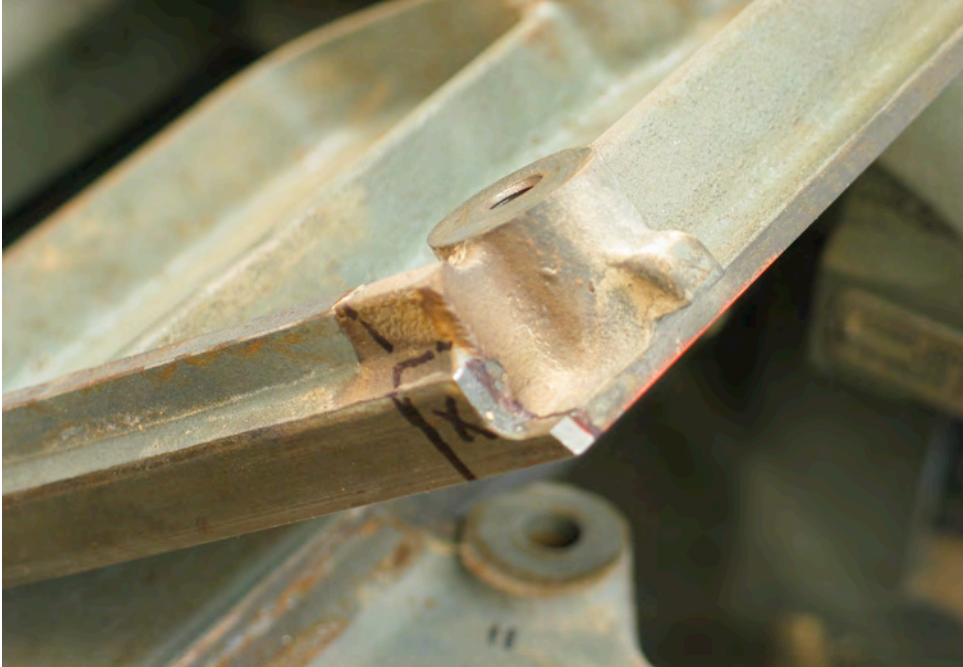
Figure 20 Table is removed after the cut area is marked

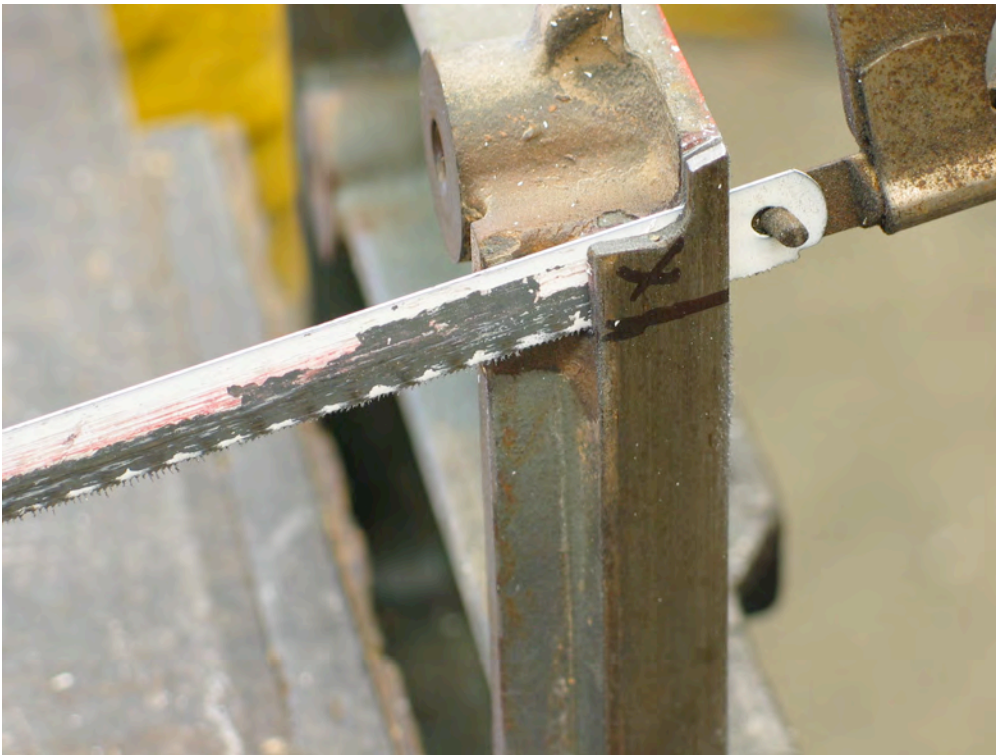
Figure 21 A hacksaw makes quick work of this detail.

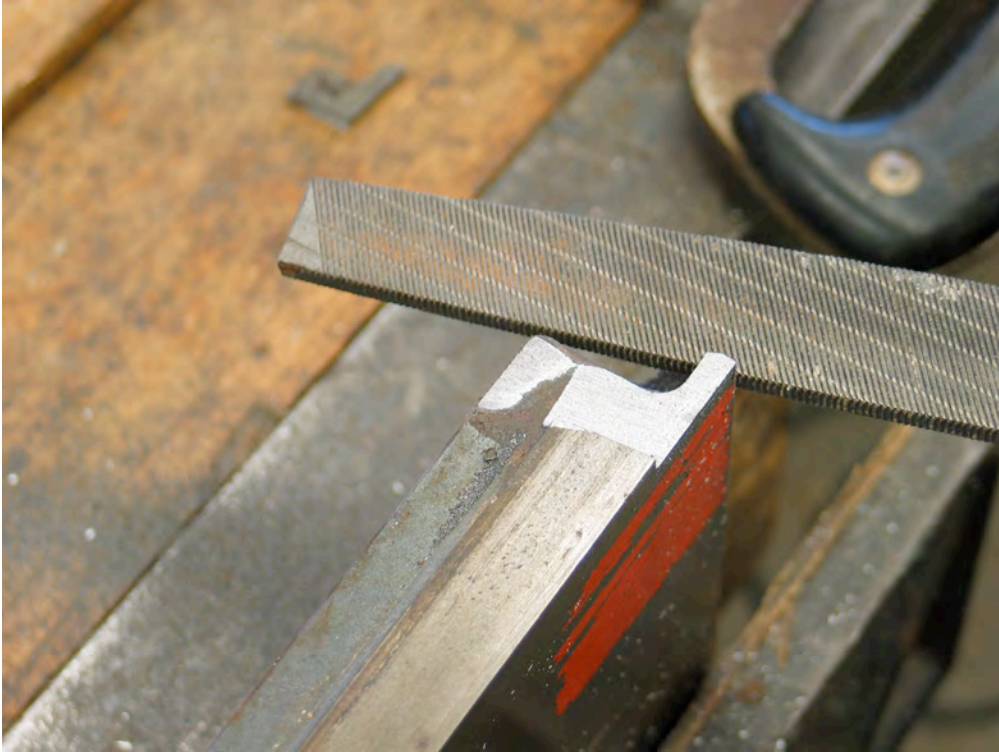
Figure 22 Clean up the hacksaw marks with a file.

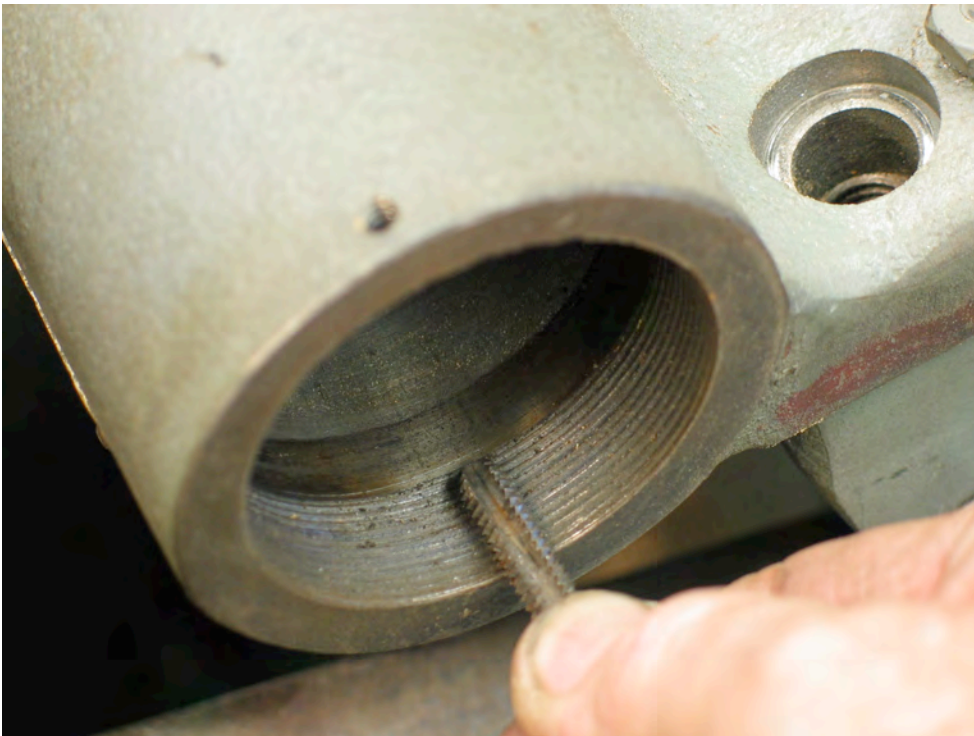
Figure 23 Clean the threads with a 1/4-20 tap so the spanner nuts will install easily.

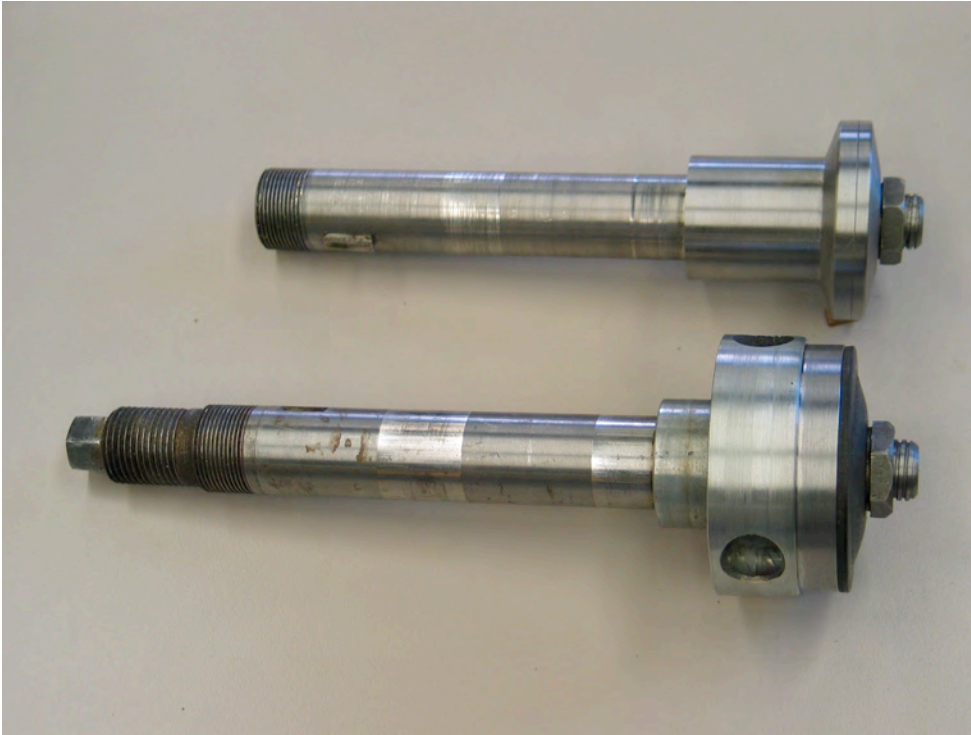
Figure 24 Here's two approaches to a solution. Both use a Unisaw LH nut. The top shaft is newly made with a smaller blade flange (2-1/4"). The lower flange uses a newly made face plate held in with the original drawbar.

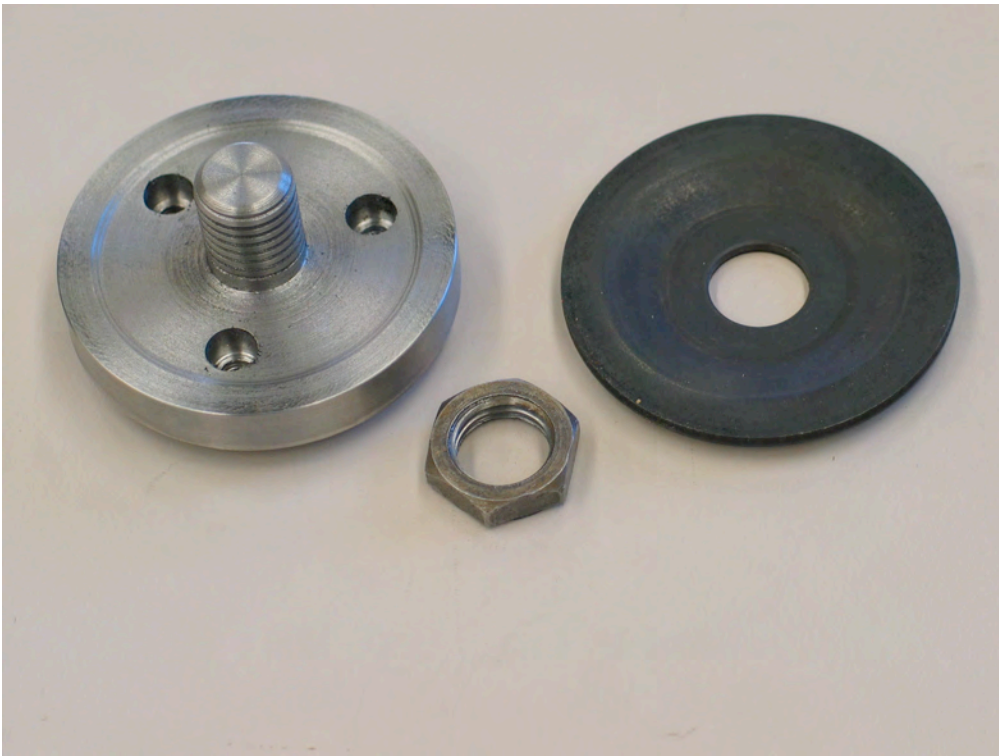
Figure 27 Front side of new faceplate. Note the countersunk holes for the capscrews. The machinist making this part will determine the dimensions.

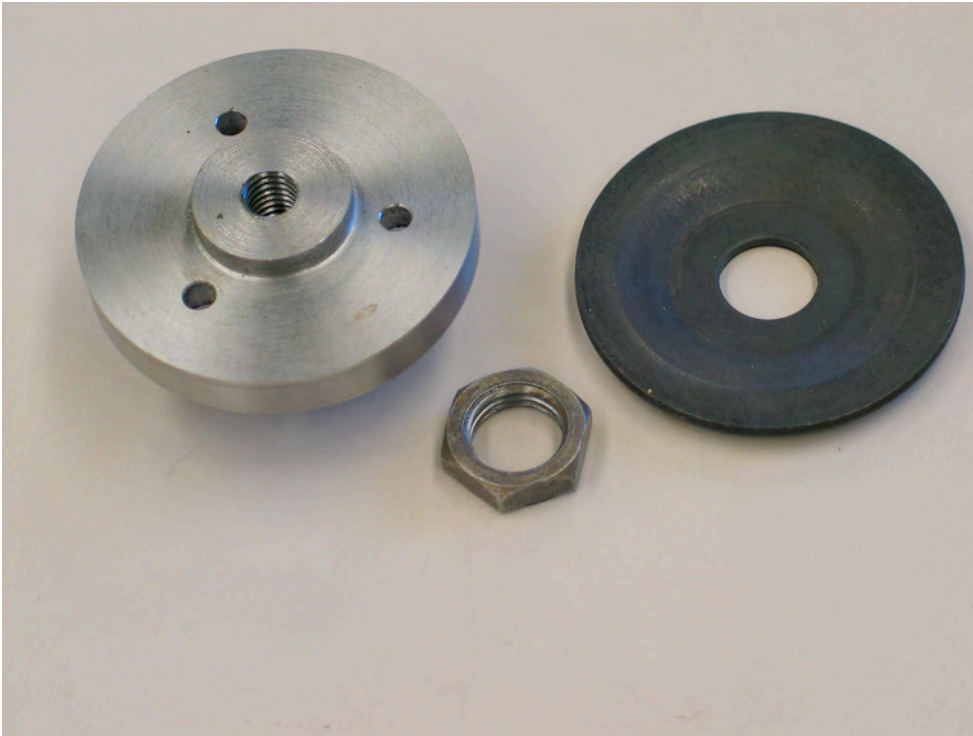
Figure 28 The back side of the faceplate showing threaded hole for 3/8-16 drawbar. This is an inexpensive fix, but not as accurate as an entirely new shaft.

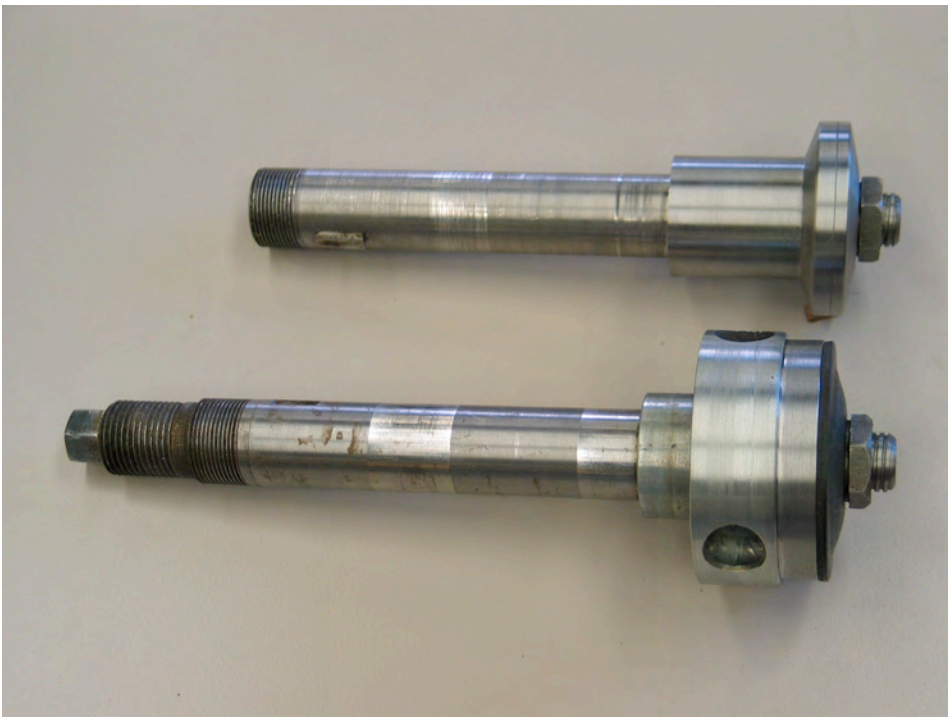
Figure 2921 For comparison, the top shaft is the new one and the bottom one is the faceplate style. Note the different dimensions around the flange.

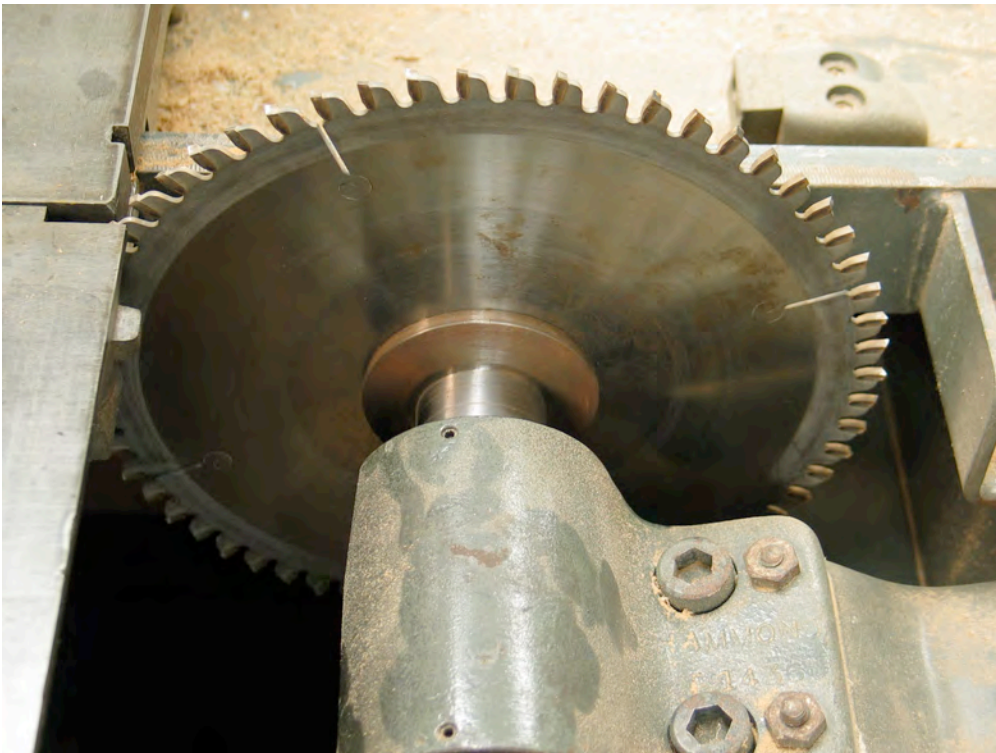
Figure 31 For contrast, this photo shows the "Bench" glider model that doesn't require cutting for blade clearance.

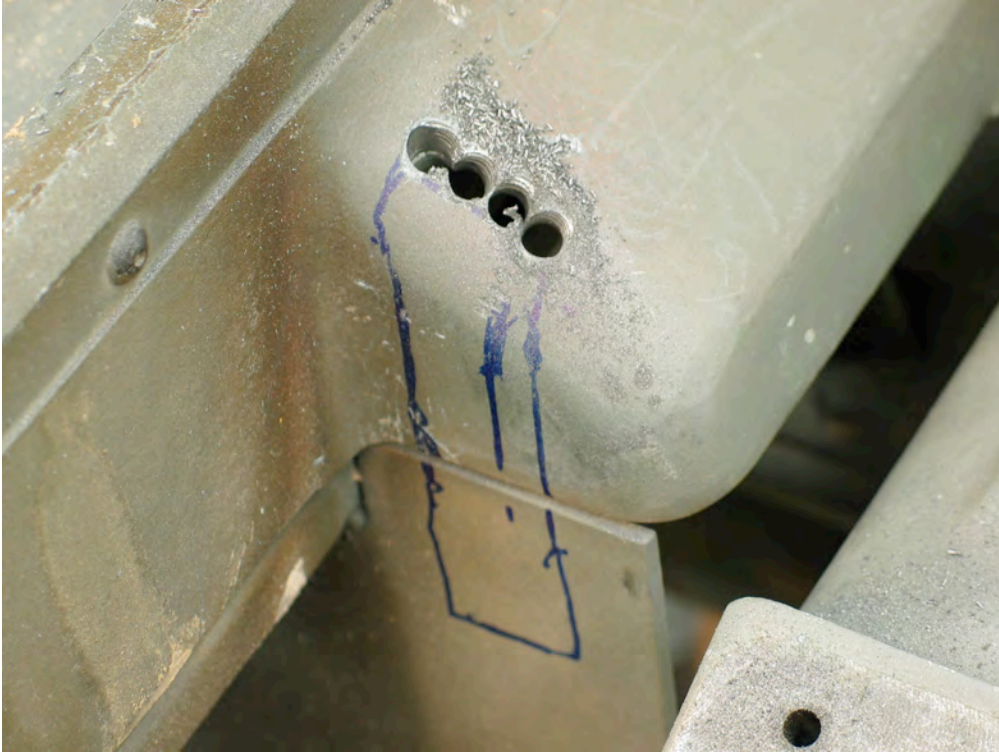
Figure 256 Holes neatly done. The sheet metal under the cast area will be cut away and not U-slotted as drawn.

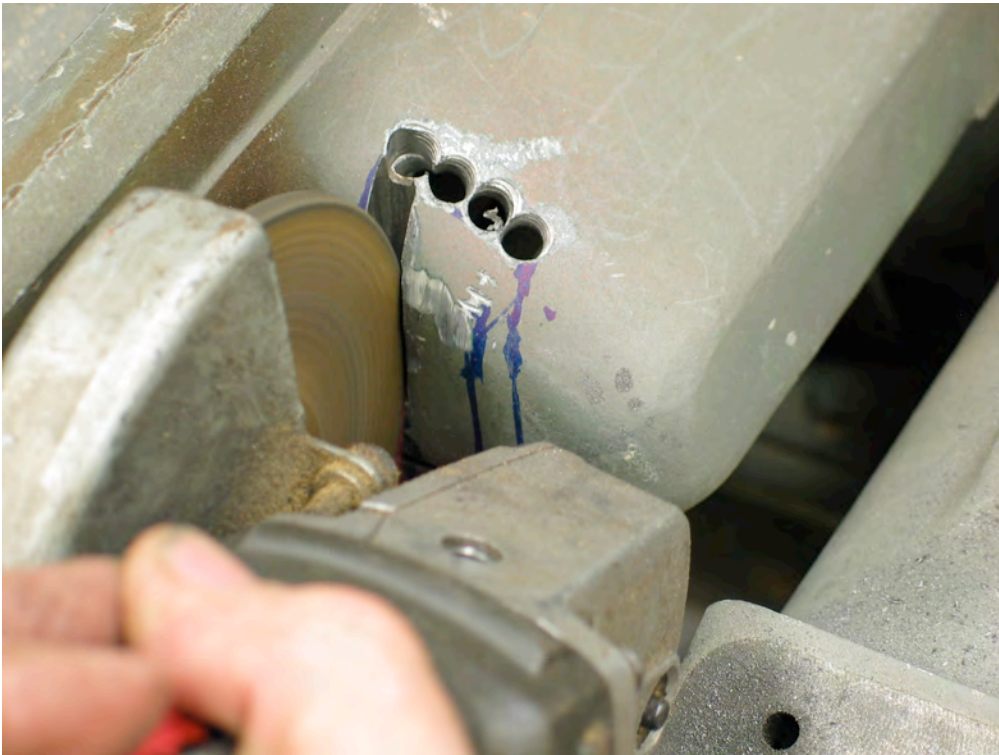
Figure 267 A 4-1/2" angle grinder does quick of cutting a slot up to the holes.

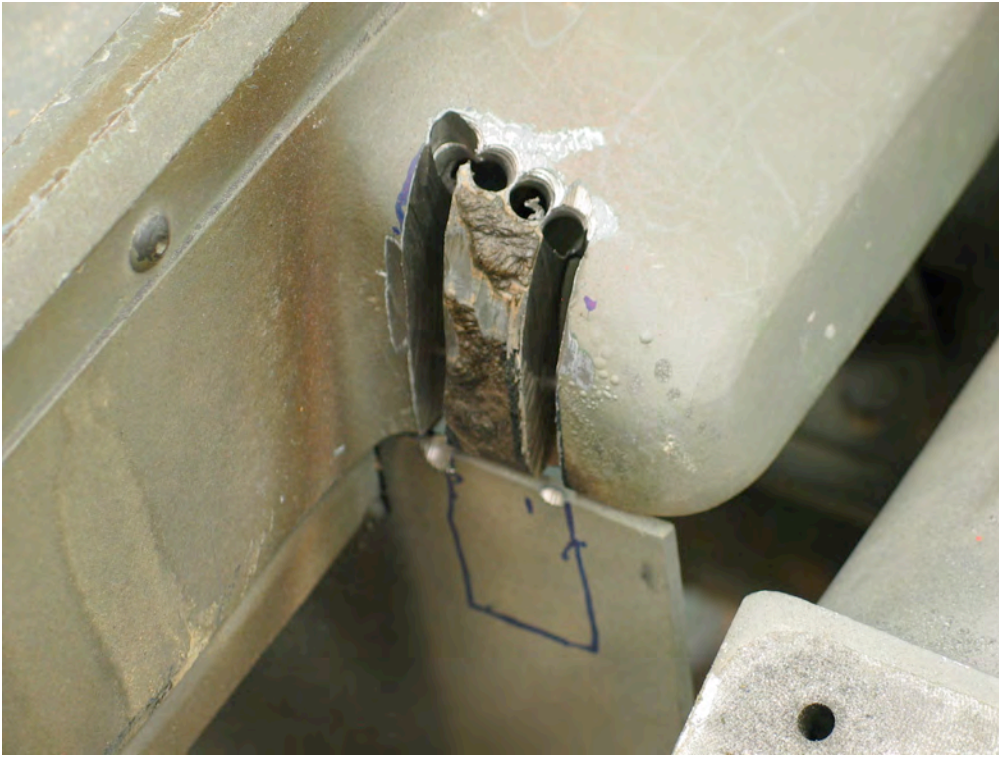
Figure 278 Slot s are not cut and the opening is ready for removal.

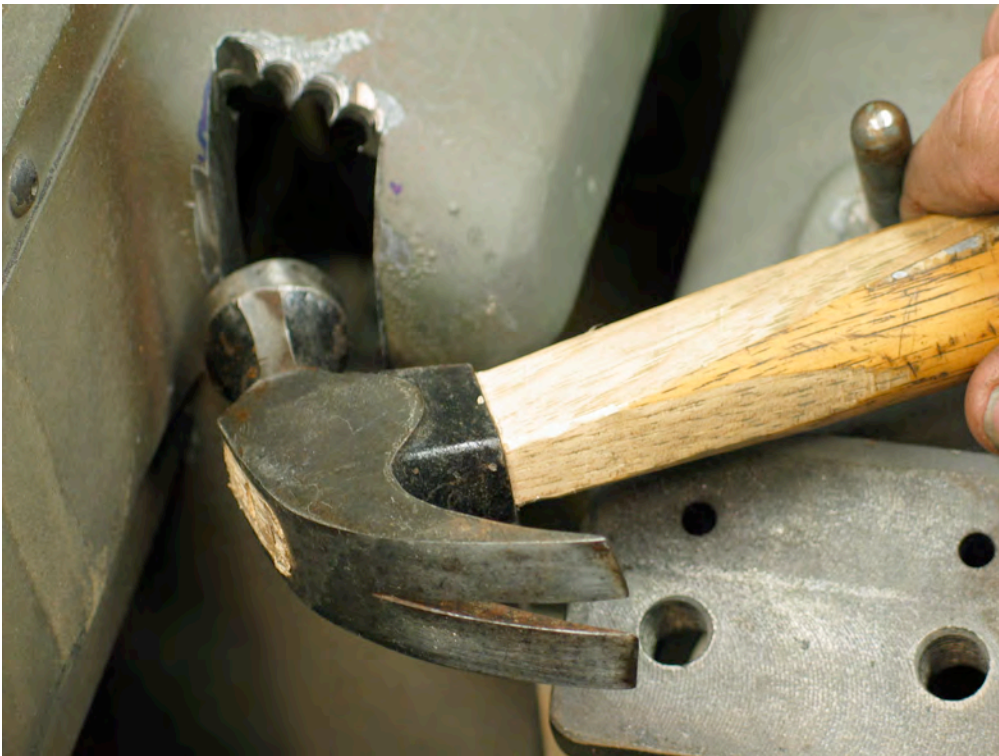
Figure 39 A light tap of a light hammer gets the job done.

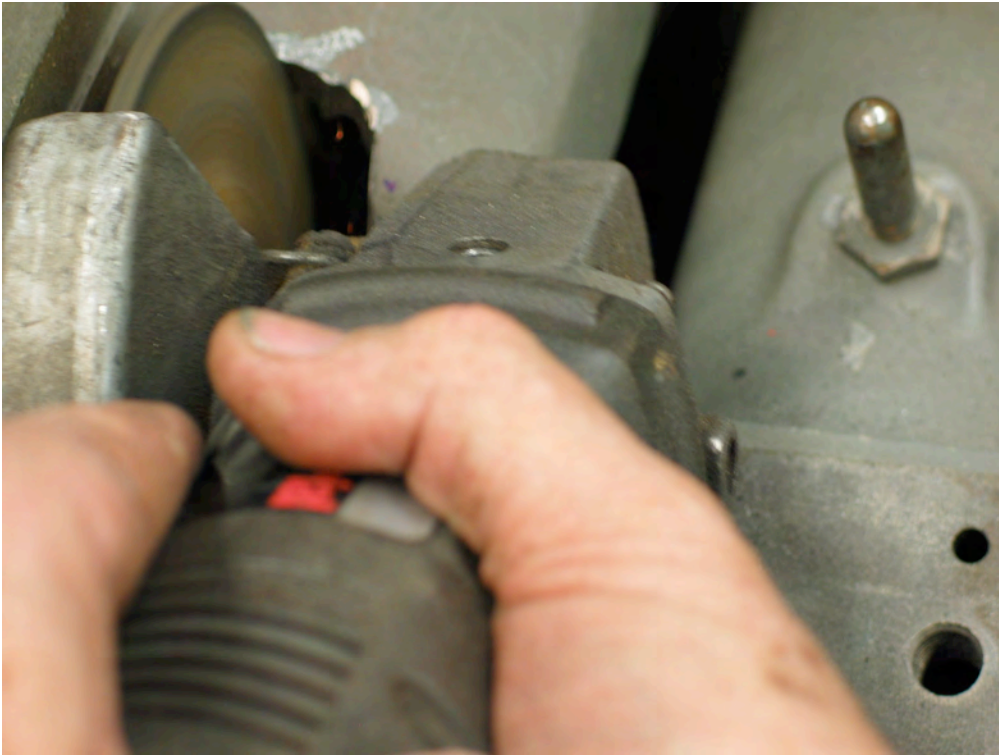
Figure 280 Net the angle grinder cleans up the top area.

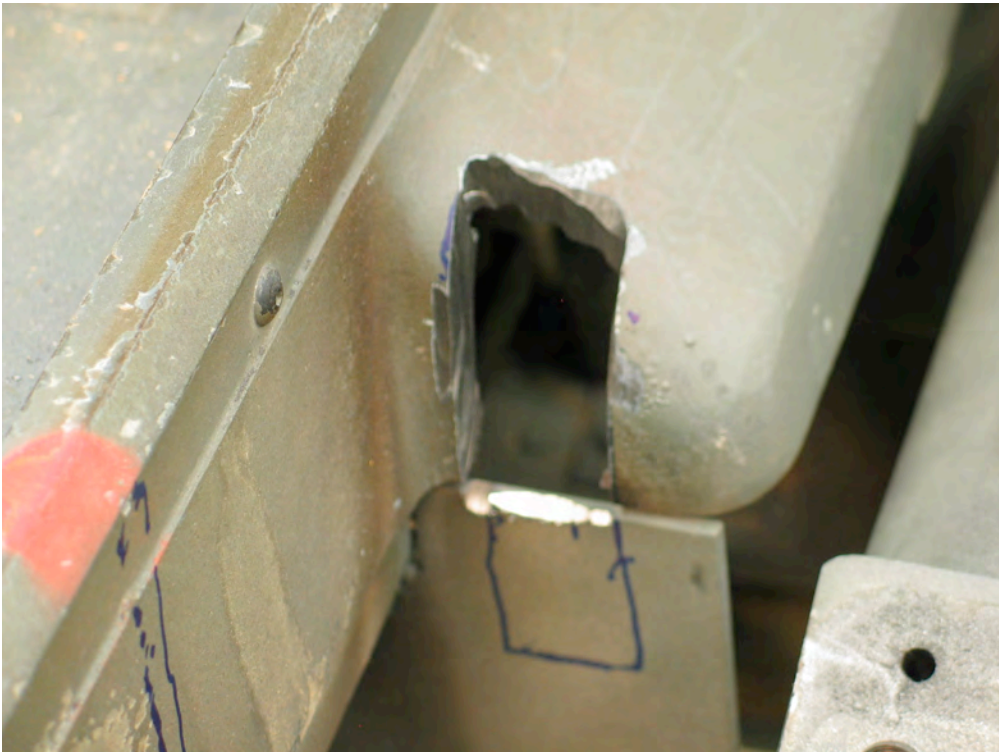
Figure 291 Opening complete and now the bottom area will be ground out.

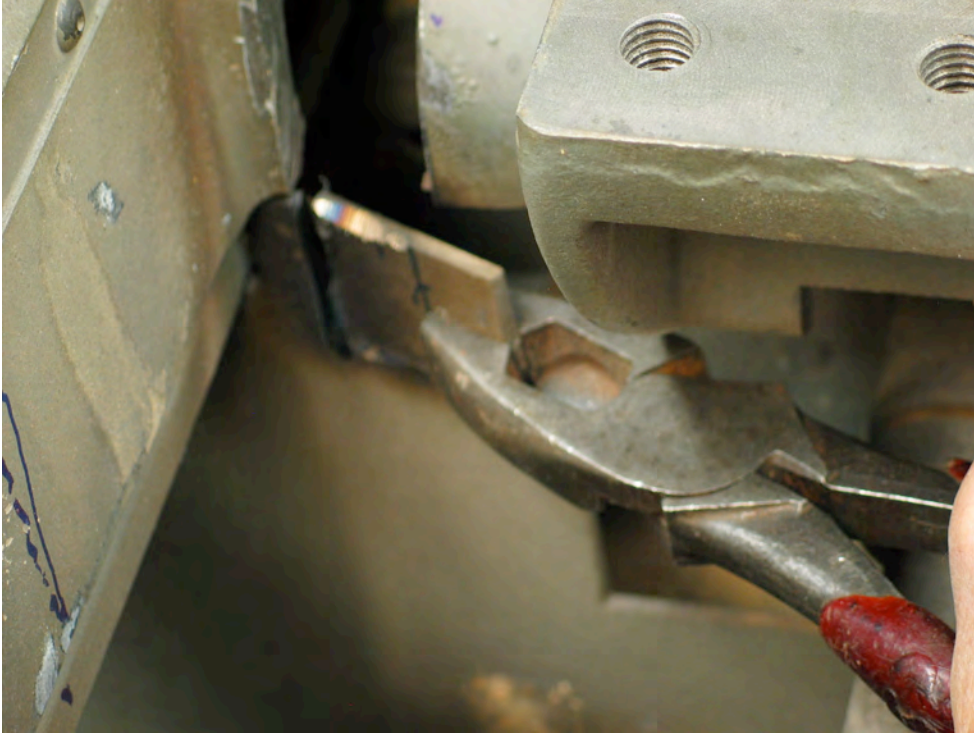
Figure 302 Once the two cuts have been made, pliers will worry out the waste.

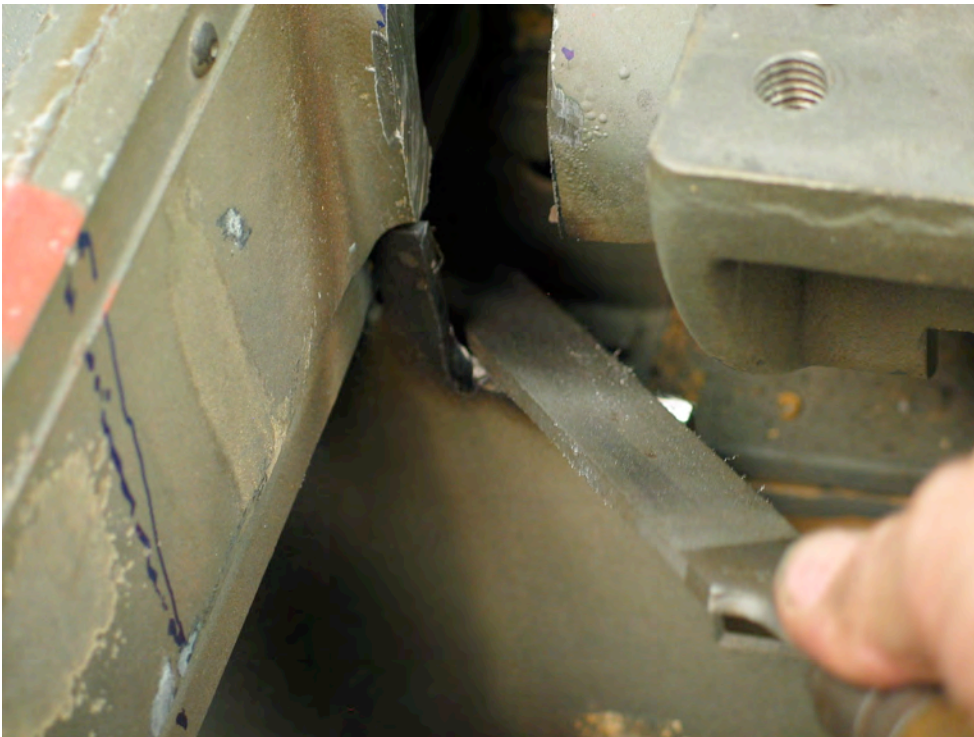
Figure 313 A little work with the file cleans up the edge.

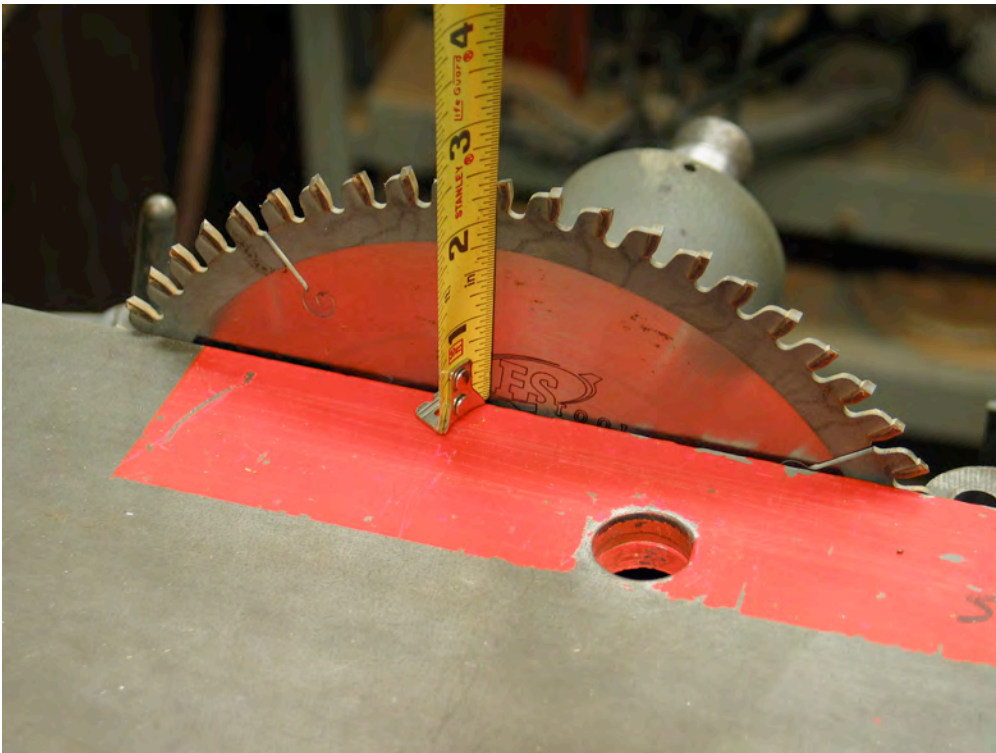
Figure 335 Cutting height with the new arbor will be slightly shy of 2-1/2 inches, a very acceptable range for a saw this small.

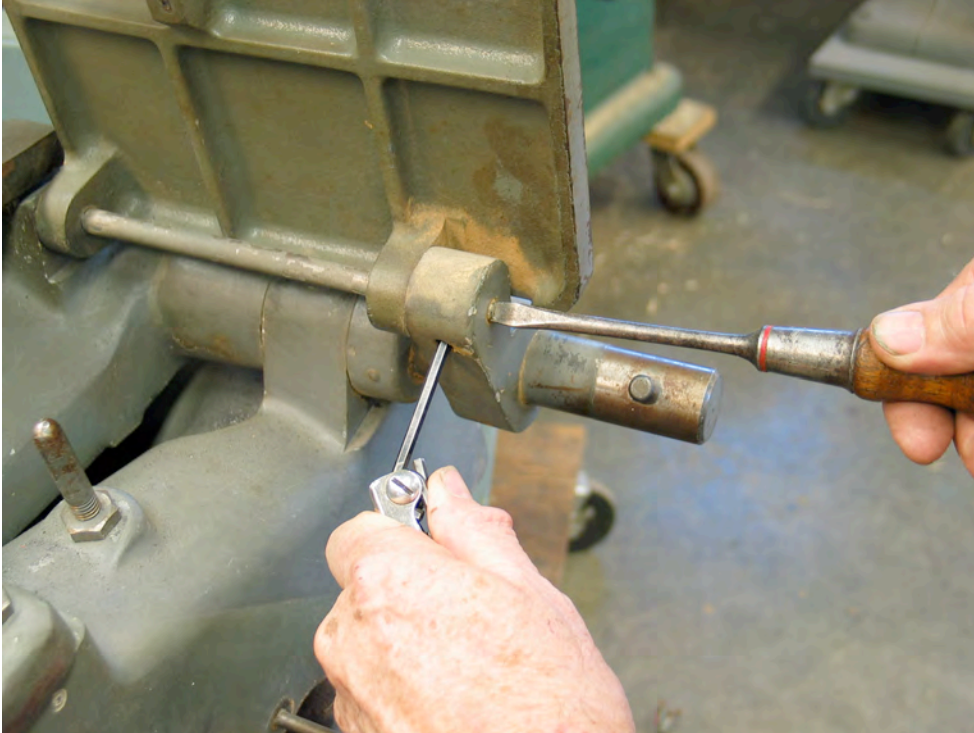
Figure 346 The position of the back table can be adjusted by loosening the rod setscrew and turning the slotted end of the rod with a screwdriver.
