Modifying a Hammond Glider

By Bob Vaughan

The objective with this Hammond glider modification was to modify it to accept the 8-1/2 inch size blade so popular on miter saws plus install a single phase motor and get the saw up to 4500 rpm by installing new pulleys.

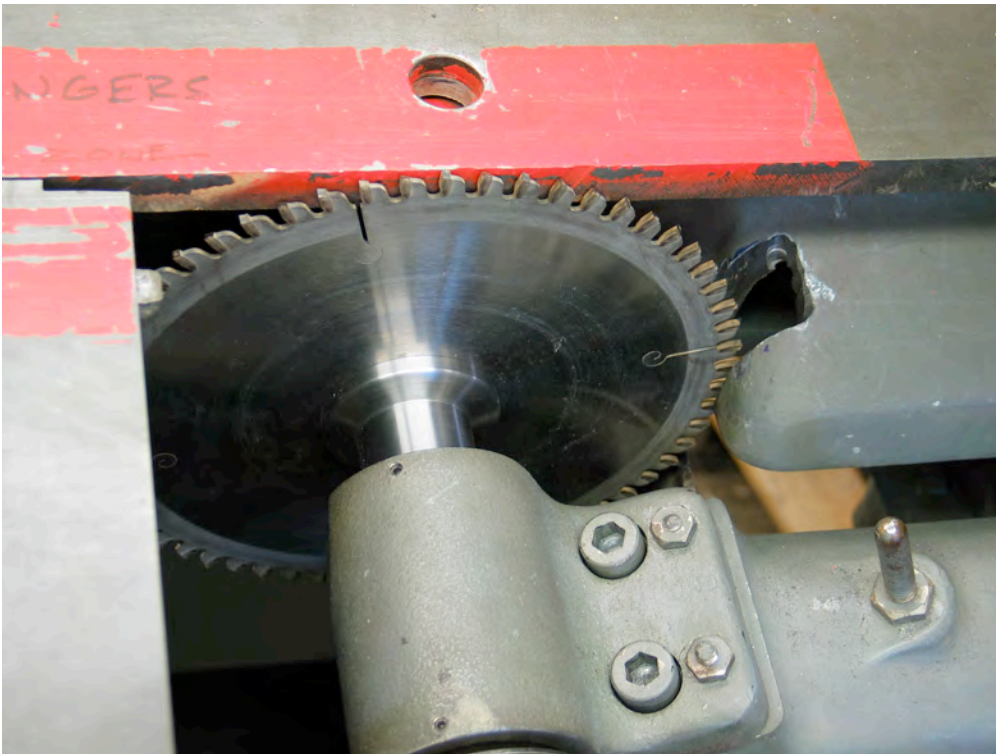
Figure 357 The installed blade ready to go.

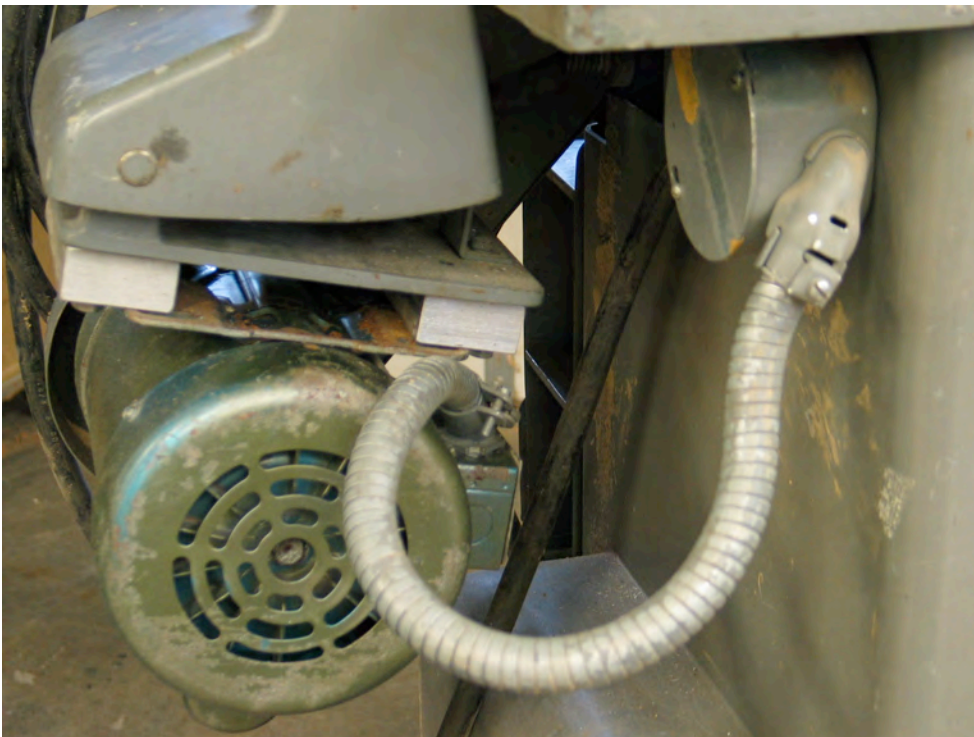
Figure 49 The 56 frame, 3450 rpm motor installed

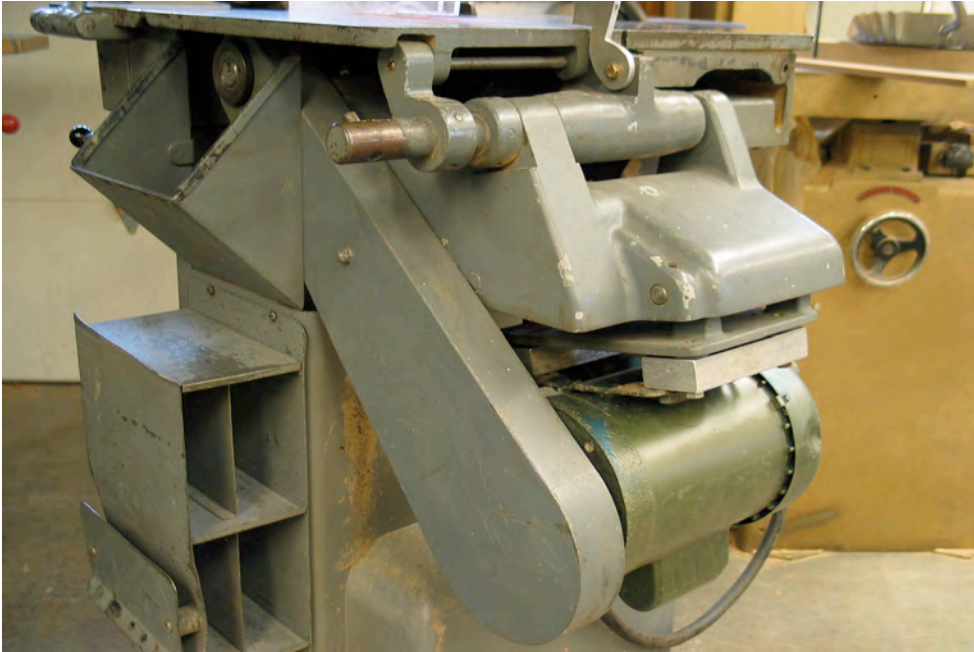
Figure 50 side view of the new motor installation.

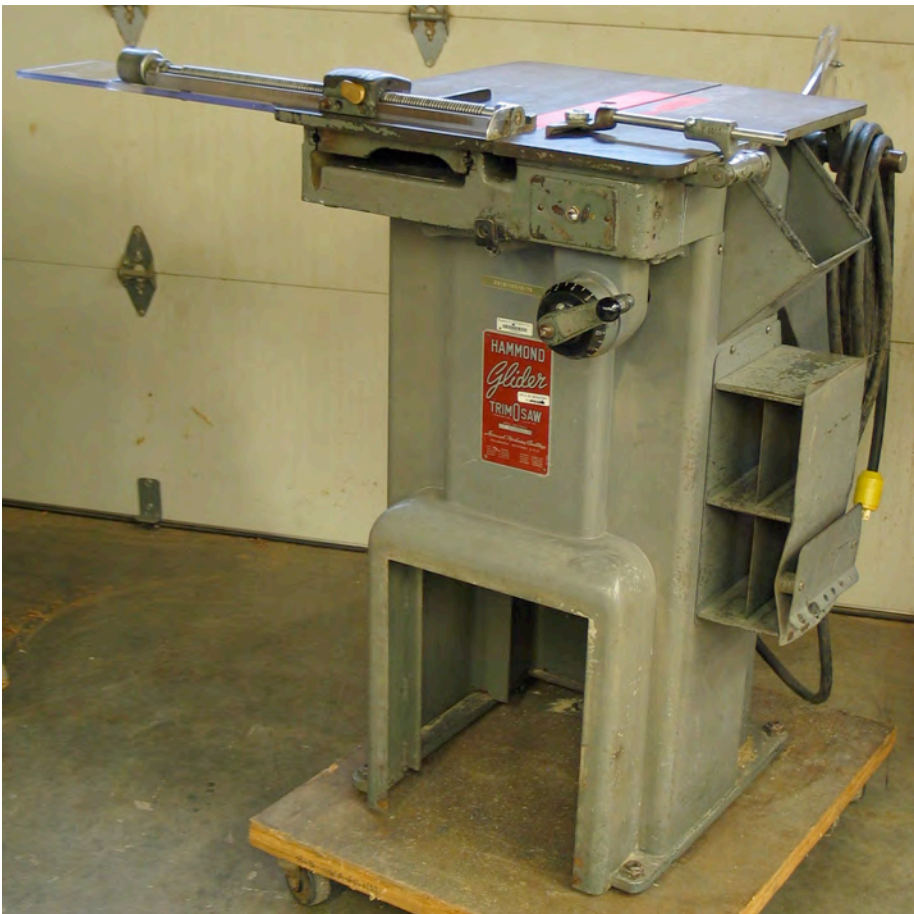
Figure 37 The restored saw, ready for service.
